**1976 Hatteras 48 Long Range Cruiser 48.8 LOA (w/o pulpit)**

**"Sample Vessel"**

September, 21st and 22nd of 2022

# Report of Marine Survey

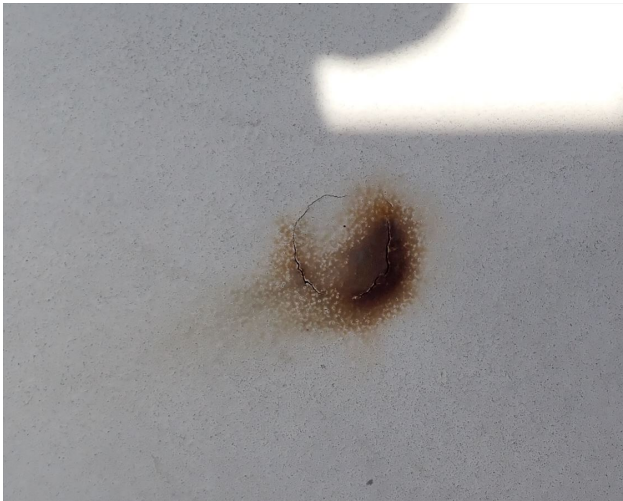
A) One area of deck delimitation with elevated moisture content was observed near the seating in front of pilot house on the starboard side. (Indicated by brown circular stain shown in photo)

A) Investigate further, and repair in accordance with good marine practice as necessary.

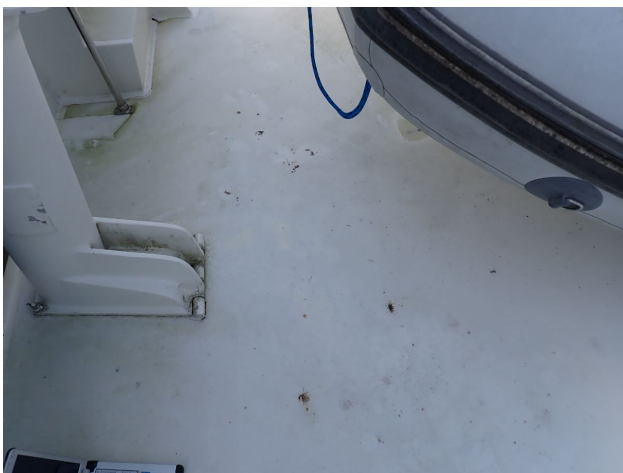
#### FINDING C-3

Nonskid painted surface showing wear on locations.

Investigate further, and repair in accordance with good marine practice as necessary.

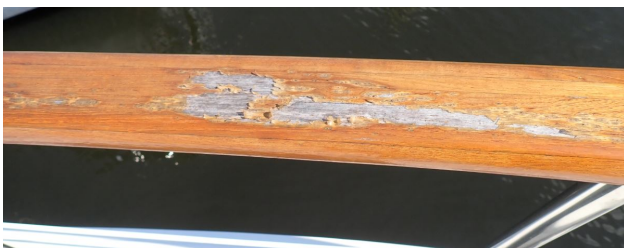
Some of the exterior Teak bright work varnish had UV weathering, lifting, and lightening or moisture darkening.

Refinish the bright work, as necessary.

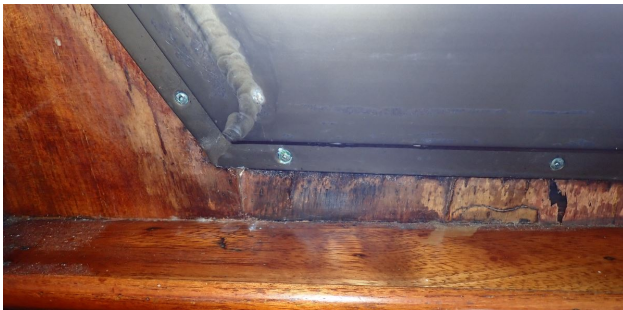
Both aft sections of the saloon windows have cracks in glass. Starboard side window in saloon shows signs of previous water leak.

Investigate further/trace, and service, repair or replace as necessary.

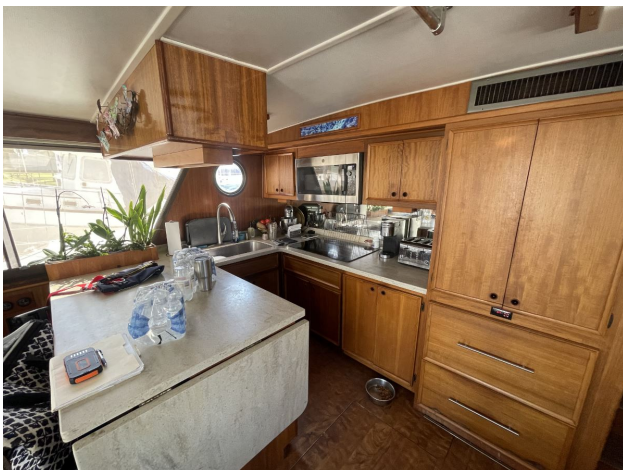
### FINDING C-8

There appeared to be condensation damage to the wood below the drawer refrigerators.

Repair as necessary.

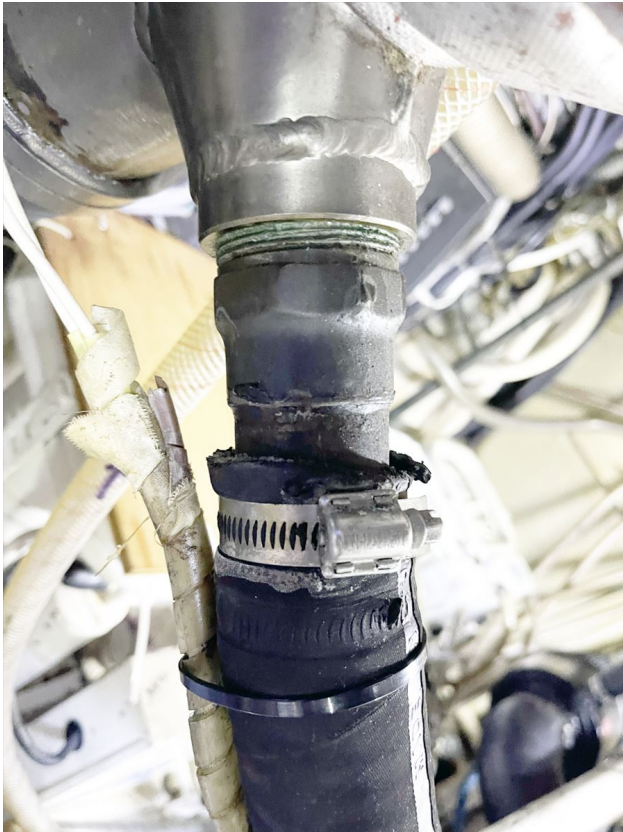
Port side engine raw water hose to exhaust injection elbow is missing a hose clamp and may have slipped as compared to the starboard side configuration.

Investigate further, and service, repair or replace as necessary.

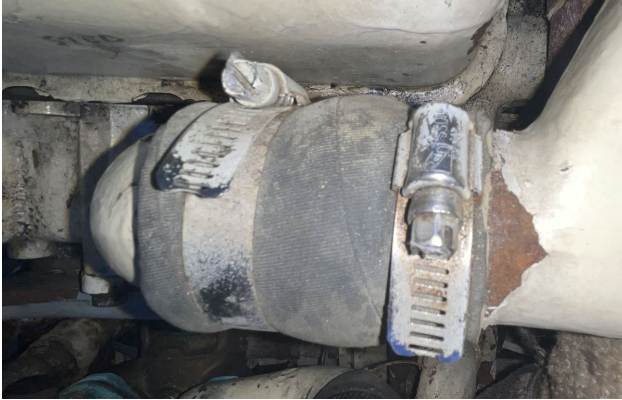
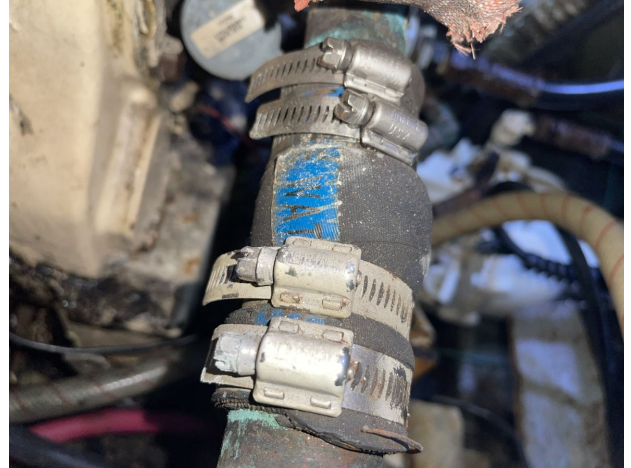
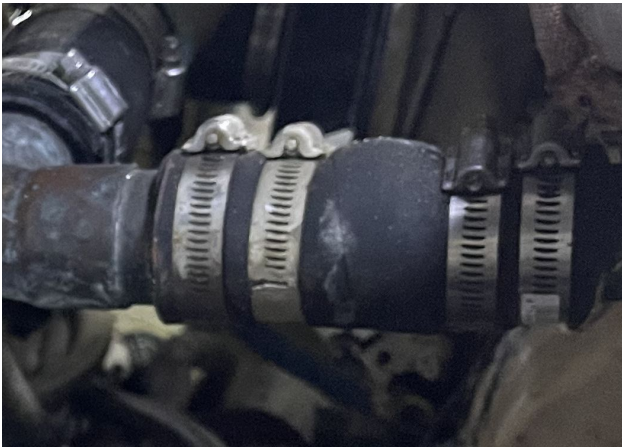
A) Several cooling hoses on both engines were bulging and showing stress. In addition, many of the hose clamps were showing rust and cracking.

B) Corrosion was observed on both engine's raw water impeller pumps, heat exchangers and transmission coolers.

A) Investigate further, and service, repair or replace as necessary.

B) Investigate further, and service, repair or replace as necessary.

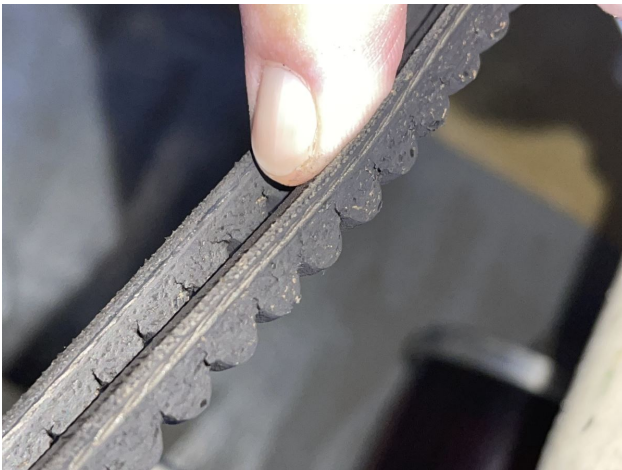
Engine drive belts were dried and cracked.

Investigate further, and replace belts as necessary. Properly tighten belt adjustment.

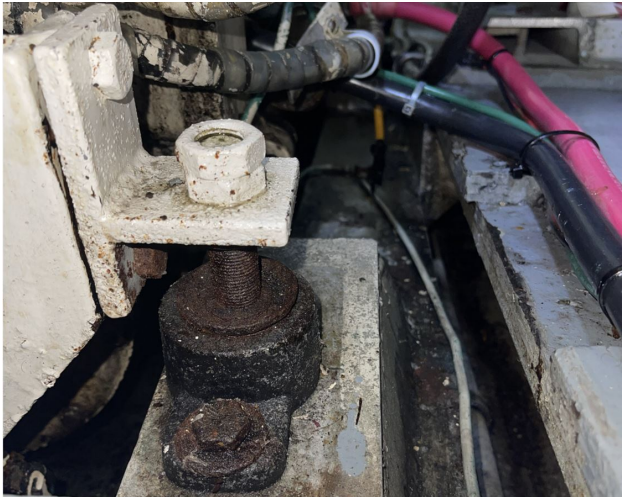
The engine mounts are showing rust and the outboard aft mounts on both engines are adjusted to their maximum high, which imparts extra stress on the components.

Investigate further, and service, repair or replace as necessary.

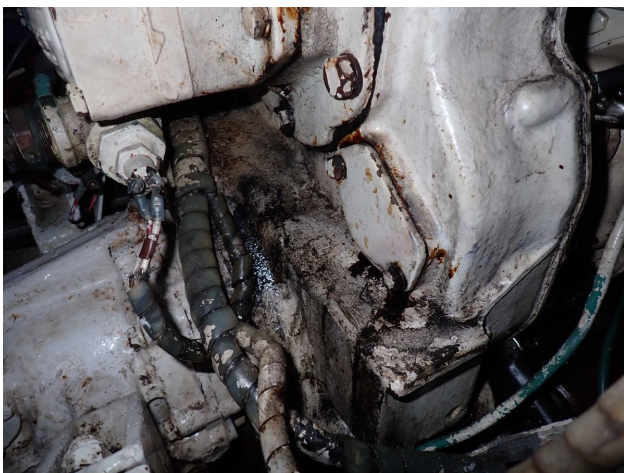
Both engines were leaking oil at several locations.

Investigate further/trace, and service, repair or replace as necessary.

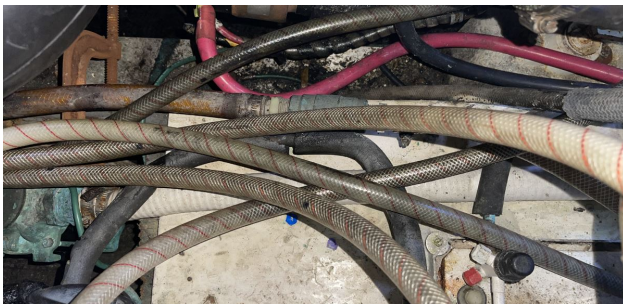
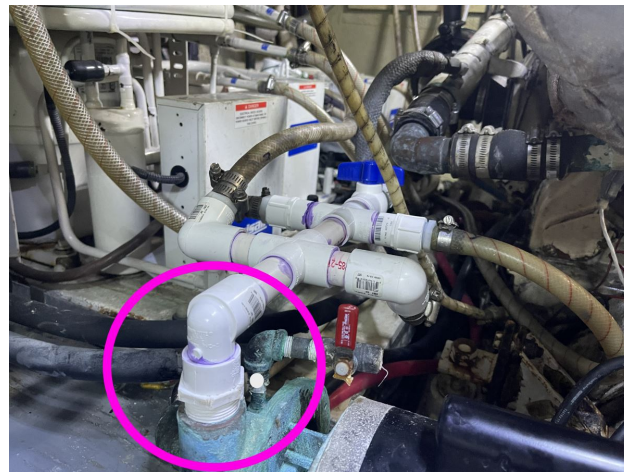
B) The air conditioning's raw water distribution manifold is constructed of PVC, which is not a violation of rules: however, the way in which it is constructed makes the elbow circled very vulnerable to breakage if pressure is placed on the other end of the manifold.

C) The watermaker low pressure pump's hose was not recommended for raw water suction use (collapsible type hose).

B) Investigate further, and refit or replace as necessary.

C) Replace the hoses with reinforced "non-collapsible" type, as necessary.

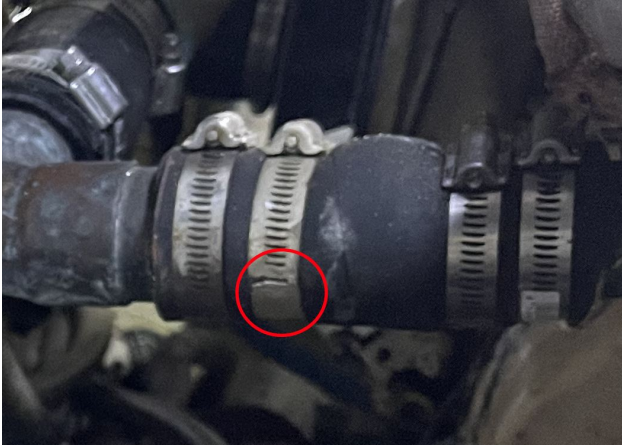
Several of the vessel's below deck/bilge hose clamps have developed partial failures. Several of the engine's exhaust hose clamps and some of the bilge hose clamps (including the shaft seal boot hose clamps) have developed general rust.

Inspect all hose clamps and clean or replace with doubled Marine Grade Stainless Steel clamps where appropriate, as necessary.

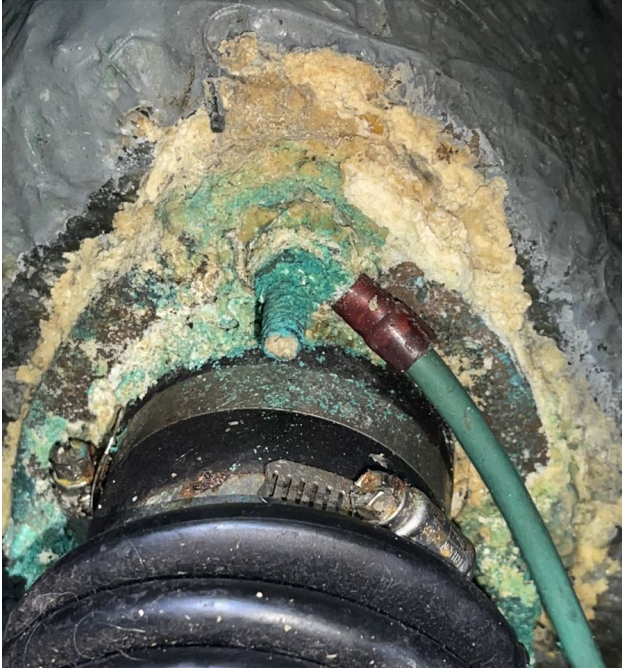
A) The shaft logs on both port and starboard showed signs of leaking with significant amount of build-up attacking metal and bonding connections.

B) Hose clamps were showing signs of rust.

C) Both of the dripless shaft seal cooling and crossover hose's fittings were corroded with dry salt residues, indicating raw water leakage.

A) Investigate further, and refit or replace fittings as necessary.

B) Investigate further, and refit or replace clamps as necessary.

C) Investigate further, and adjust, refit, or replace the seals and hose fittings as necessary.

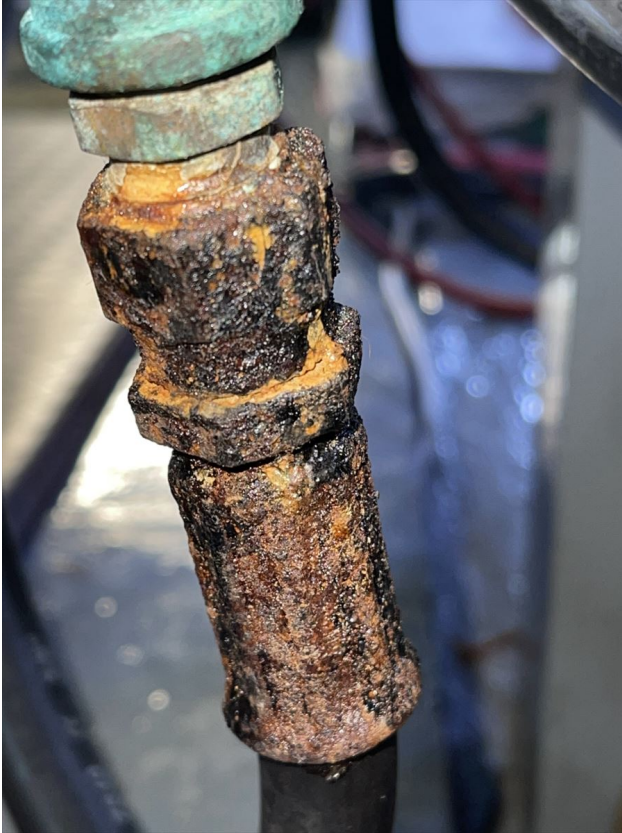
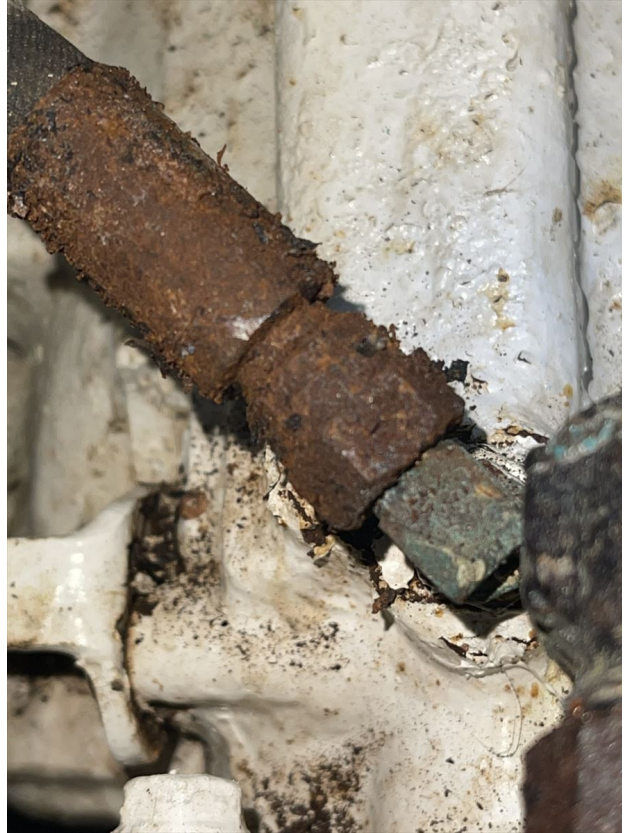
The gear and engine used many JIC fittings that were rusty.

Investigate further/trace, and service, repair or replace as necessary.

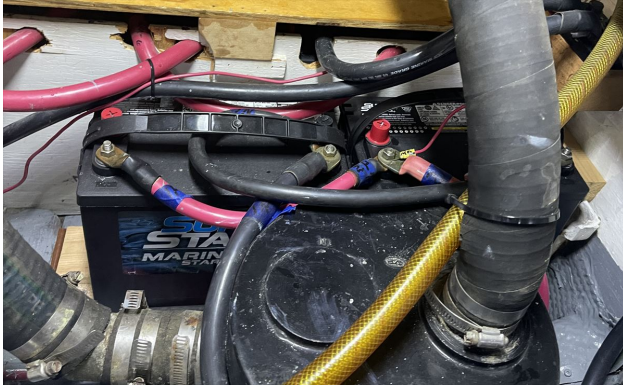
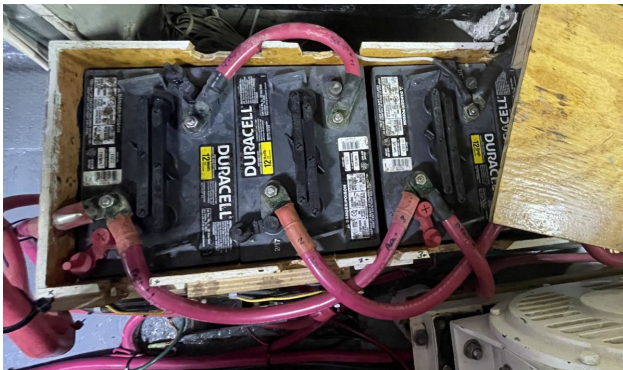
### FINDING B-15

- A) House batteries had at least one battery with bulged case.
- B) House battery box was not constructed correctly.

- A) Investigate further/trace, and service, repair or replace as necessary.
- B) ABYC E-10 - 10.7.2 Provision shall be made to contain incidental leakage and spillage of electrolyte.
