**1976 Hatteras 48 Long Range Cruiser 48.8 LOA (w/o pulpit)**

**"Sample Vessel"**

September, 21st and 22nd of 2022

# Report of Marine Survey

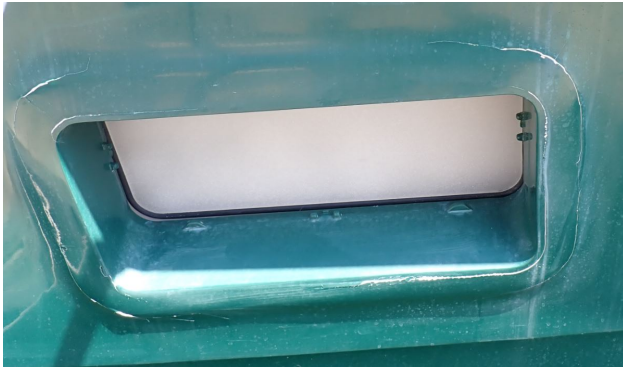
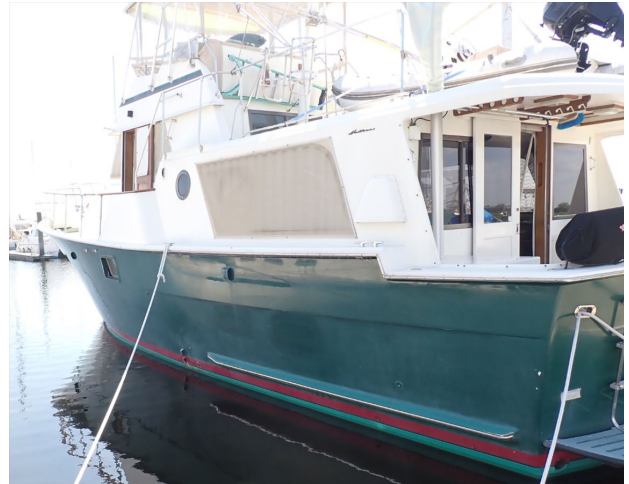
General wear & tear and oxidation was observed on most of the exterior surfaces. Some spider cracking was observed.

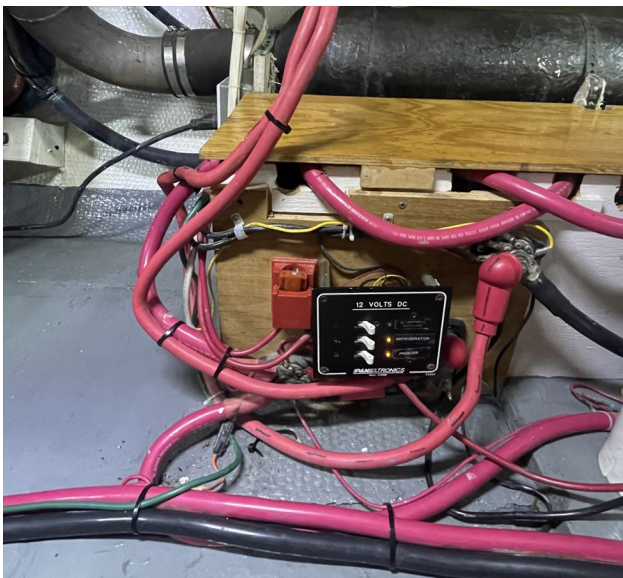
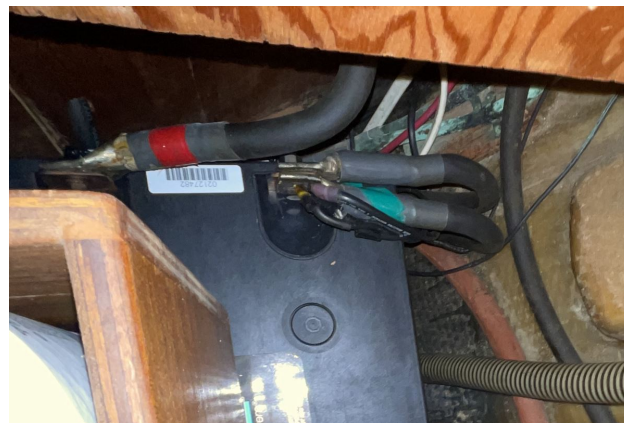
ABYC - E-10 10.7.4 Batteries, as installed, shall be restrained to not move more than one inch (25 mm) in any direction when a pulling force of twice the battery weight is applied through the center of gravity of the battery as follows: 10.7.4.1 vertically for a duration of one minute, and 10.7.4.2 horizontally and parallel to the boat's centerline for a duration of one minute fore and one minute aft, and 10.7.4.3 horizontally and perpendicular to the boat's centerline for a duration of one minute to starboard and one minute to port.

ABYC E-10 - 10.7.1 Battery mounting materials and surfaces potentially in contact with corrosive electrolytes (e.g., lead acid type) shall withstand electrolyte attack. 10.7.2 Provision shall be made to contain incidental leakage and spillage of electrolyte.

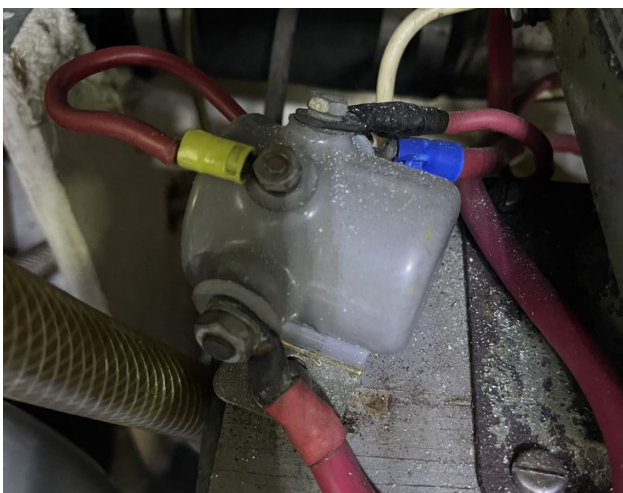
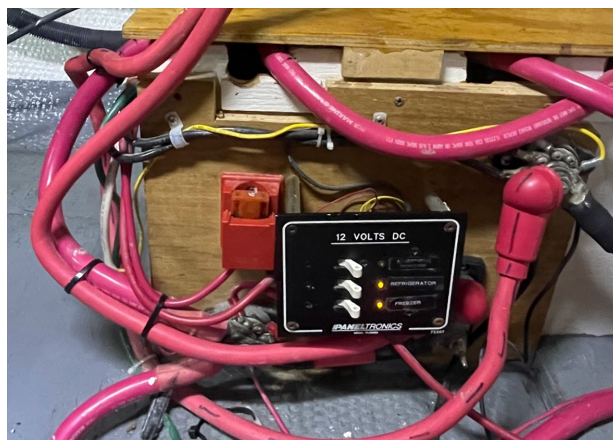
The starting battery cables for both engines ran a significant distance on top of the engine room floor where people and equipment needed to traverse over the cables.

ABYC E-11.15.3.10 The shanks of terminals shall be protected against accidental shorting by the use of insulation barriers or sleeves, except for those used in grounding systems.

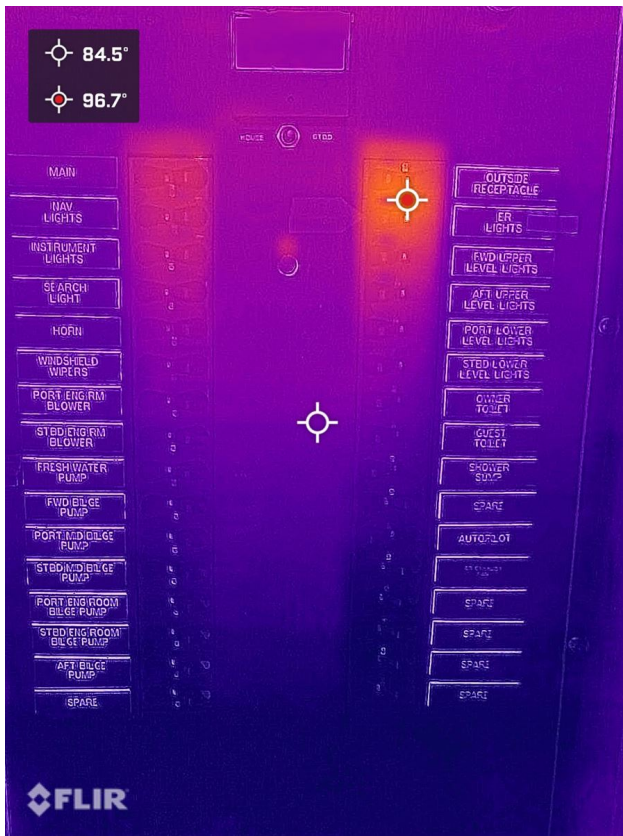
AC Electrical Panel wiring was inspected with Infrared Imaging Camera to determine if any connections were indicating increased resistance resulting from loose, corroded or undersized connections. Inspection indicated connections were within acceptable temperature range.
